Australian Transport Safety Bureau

Common Human Factors issues in recent incidents

AO-2013-130: VH-VPF 15 August 2013

AO-2013-047: A330 VH-EBV, 8 March 2013

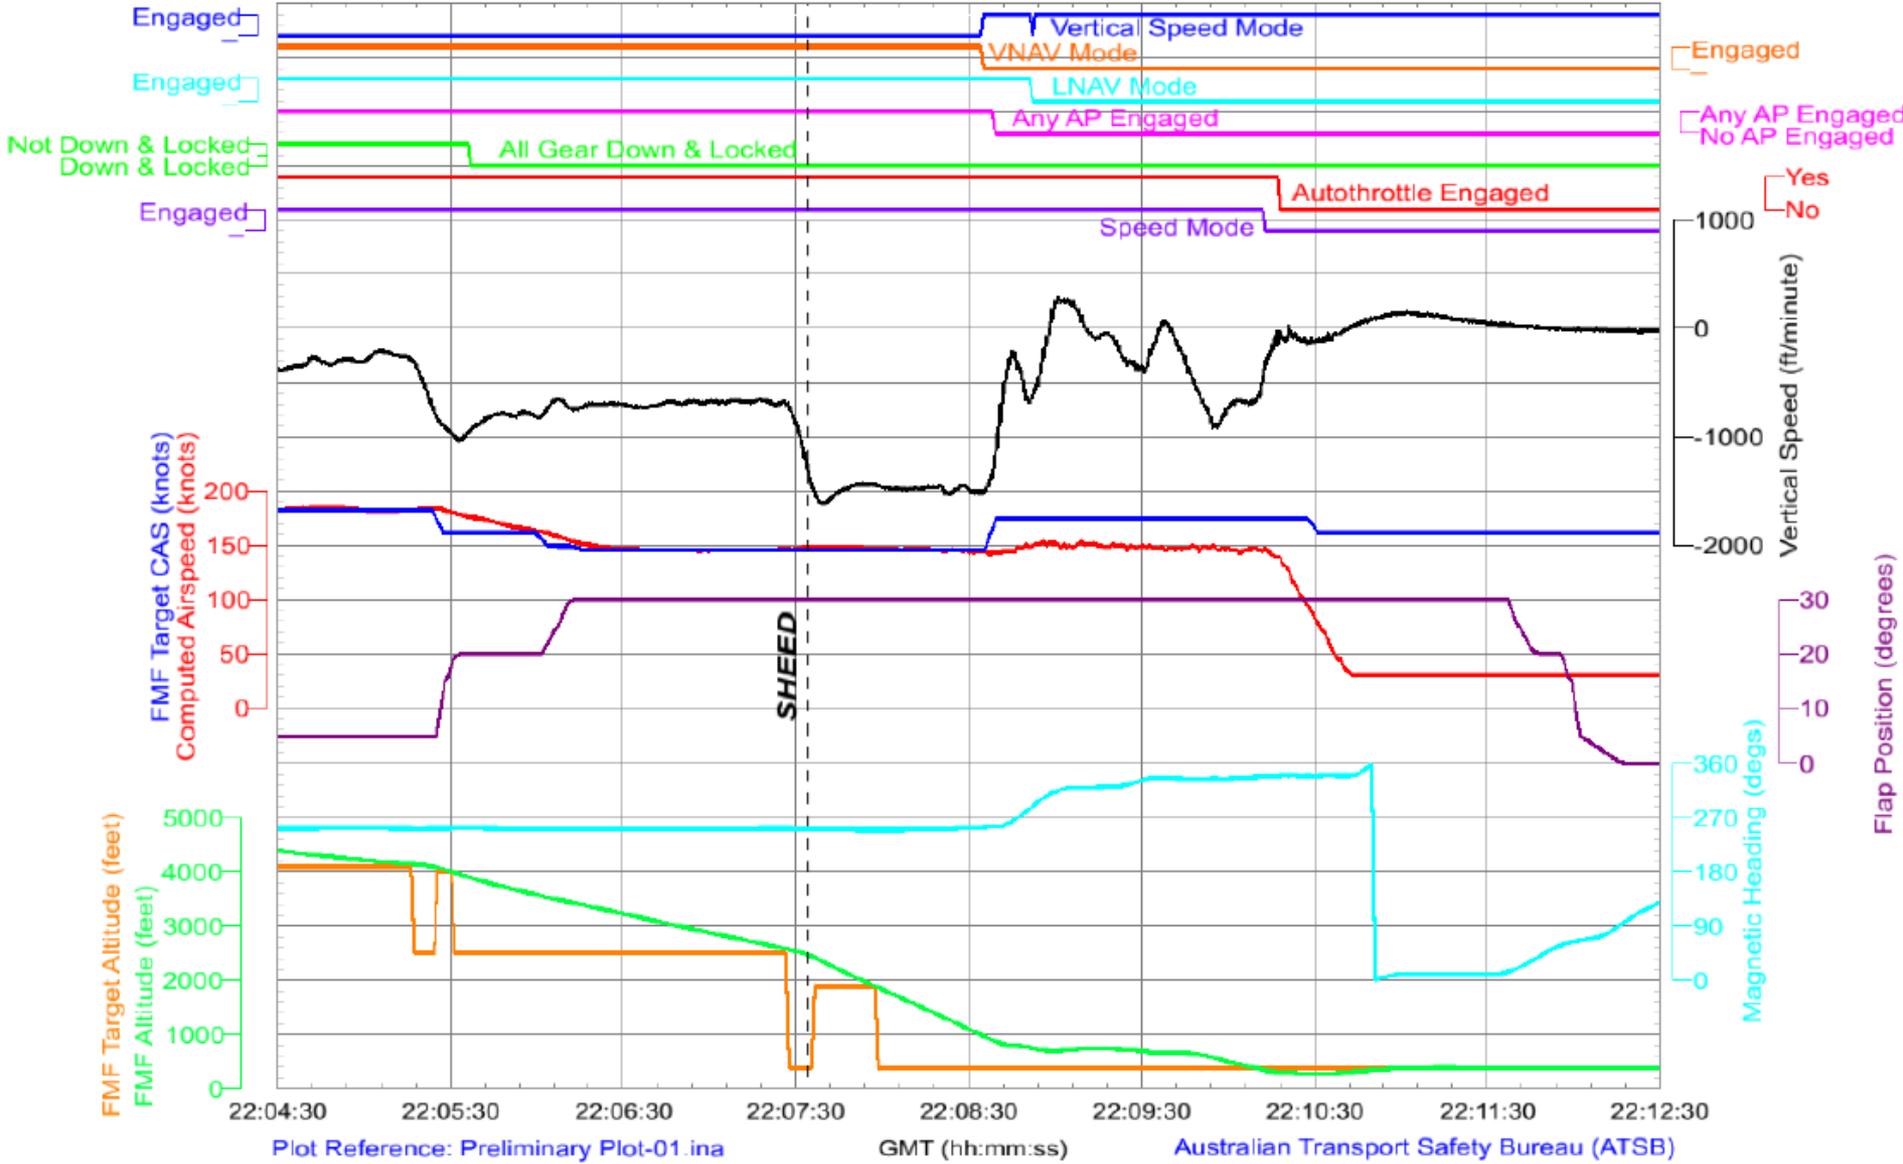
Operational Incident - VH-VPF - Boeing Company B777-3ZGER

- Crew conducting an LIZZI 7V STAR with visual final segment to runway 34
- Descent below the approach path after waypoint SHEED to a height of about 500 ft AGL
- The descent was due to a data entry error:
 - had entered the threshold crossing altitude of 380 ft
 - instead of the required value of 1,270 ft.

- During the approach onto runway 34, as they passed overhead the SHEED waypoint, the aircraft commenced a descent to reach the height for the extended runway waypoint
- FO immediately identified the descent rate as higher than normal. Captain was expecting an initial high descent rate so they continued
- Noting the captain was 'eyes in' the FO turned their attention outside and noted the aircraft was too low against approach path indicator (PAPI)

- The captain then engaged vertical speed mode to reduce the descent rate before disconnecting the autopilot and levelling at about 500 ft AGL
- The aircraft was flown level to re-intercept the approach path and landed normally.

- The captain made an error (slip) when setting up the approach and assigned the threshold crossing height as the runway extension altitude.
- In addition, the relief cruise FO had cross-checked the data but not validated it
- This may have influenced the operational crew's check in that they were aware it has been 'checked' once.

- The FO had just returned from a rest break and was not expecting to conduct a visual approach
- The similarity of waypoints RW34 and RX34 increased the likelihood that crew could misinterpret one waypoint for the other.
- The ATSB found the flight crew were probably experiencing a level of fatigue known to affect performance

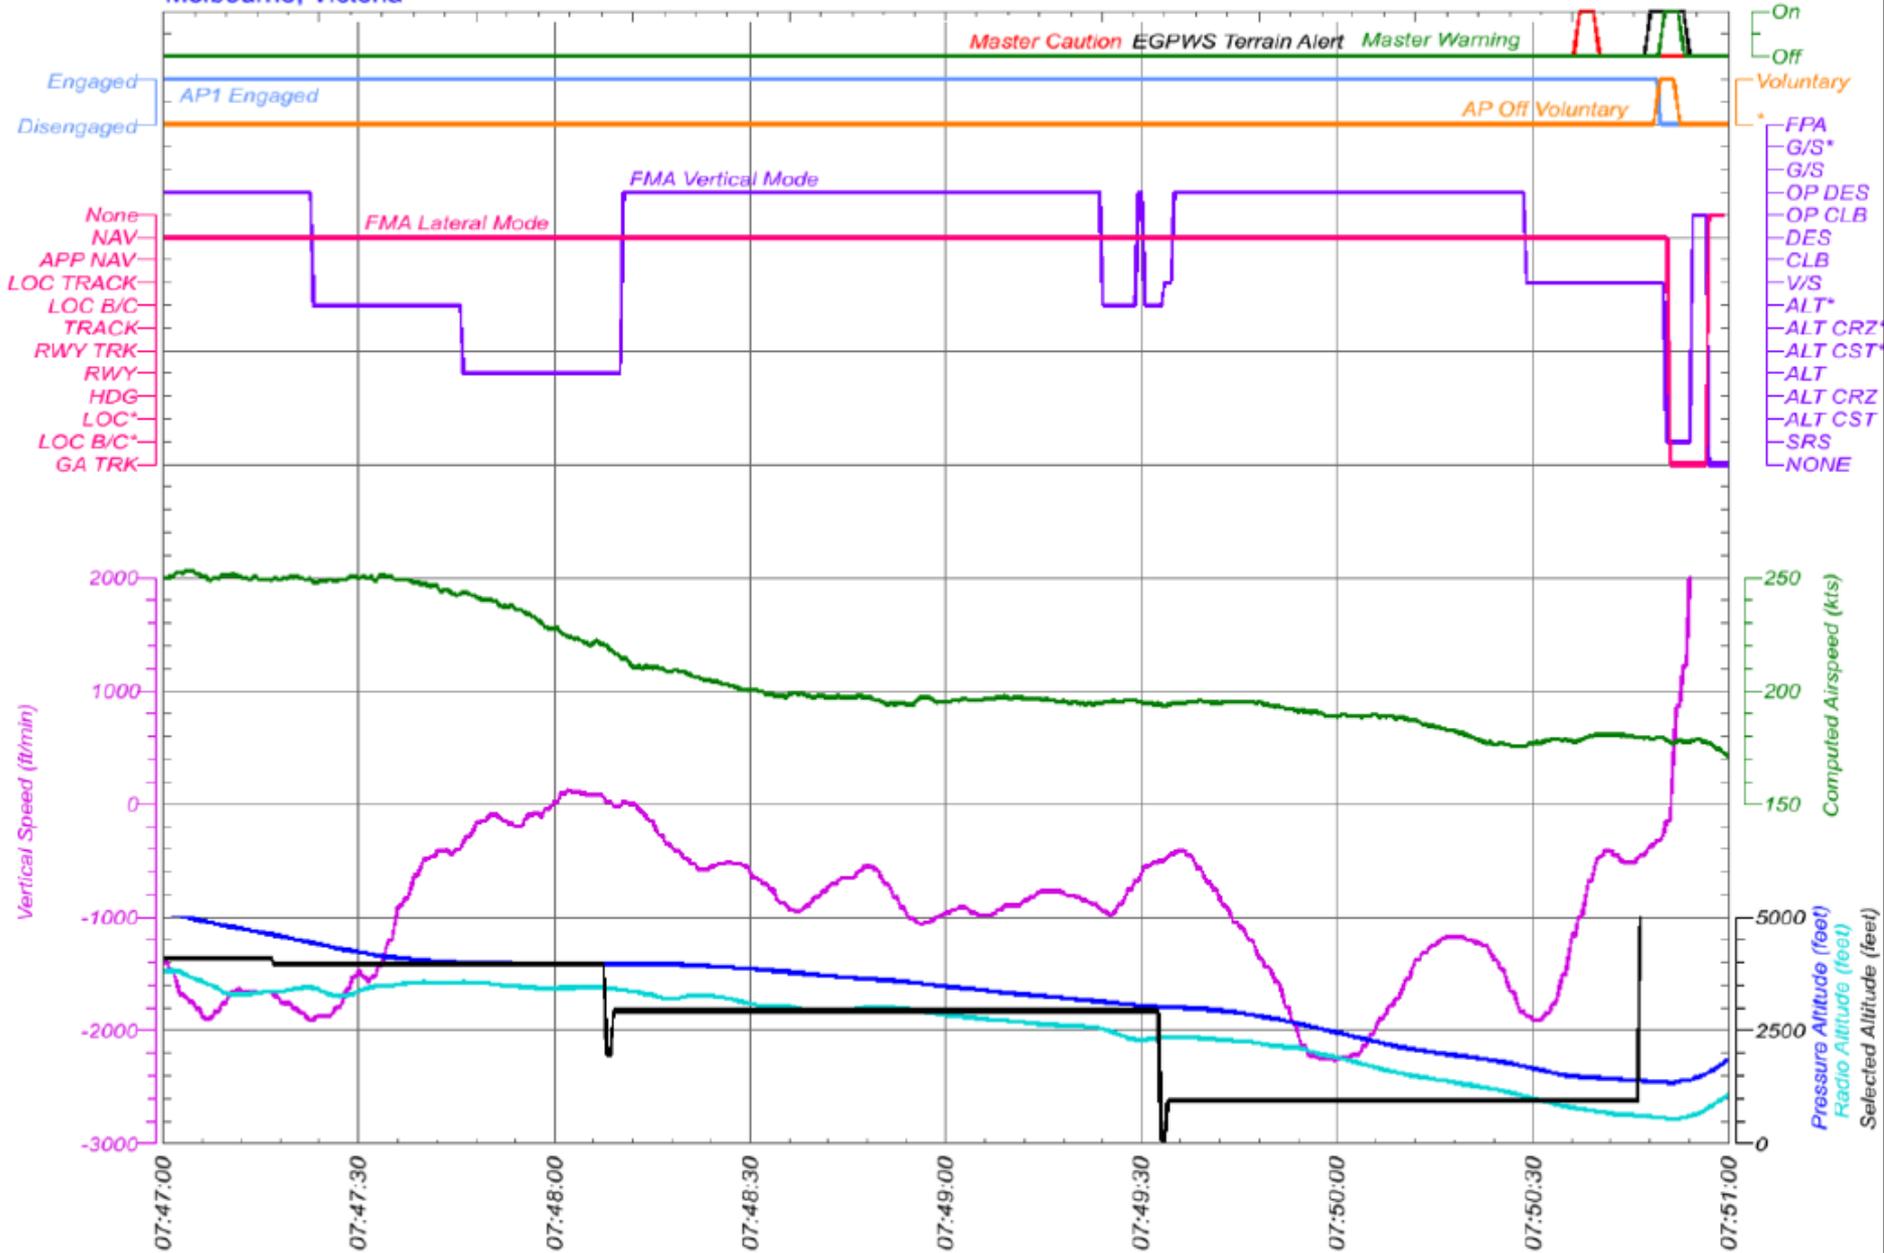
VH-EBV Airbus A330 GPWS Warning

- Crew conducting a LIZZI 6A STAR for runway 16
- Captain entered a low target altitude into FCU while the auto-flight system was in open descent
- Resulted in a deviation below the normal approach profile and descent below the control step
- During the late stage of this descent, a ground proximity warning occurred

- During the descent, the captain set 1,000 ft in the FCU
- At that stage, the aircraft was about 1,800 ft below the nominal 3° descent profile
- About 1 minute later, the FO told the captain they were 'too low'
- Captain then selected vertical speed mode and reduced the descent rate. Eight seconds later the first EGPWS 'terrain' alert activated.

- The second 'terrain' warning, and a 'PULL UP' warning activated
- Despite the day visual conditions, the captain conducted the full EGPWS recovery manoeuvre and levelled off at 4,000 ft.
- ATC vectored the aircraft for a ILS and this approach and landing were normal.

- During the approach, the captain became focused upon the spurious ILS indications showing the aircraft was high, which matched their expectation
- FO communicated the position of the aircraft as 'low' just prior to the EGPWS 'terrain' alert – too late to prevent the subsequent warnings
- FO was not aware the captain had set '1,000' in the FCU and the captain did not appear to call this selection.

- The flight crew's situation awareness was degraded during the approach, leading to an undetected flight path deviation for most of the descent.
- The operator provided limited guidance on conducting visual approaches, which was not conducive to the crew having a shared mental model

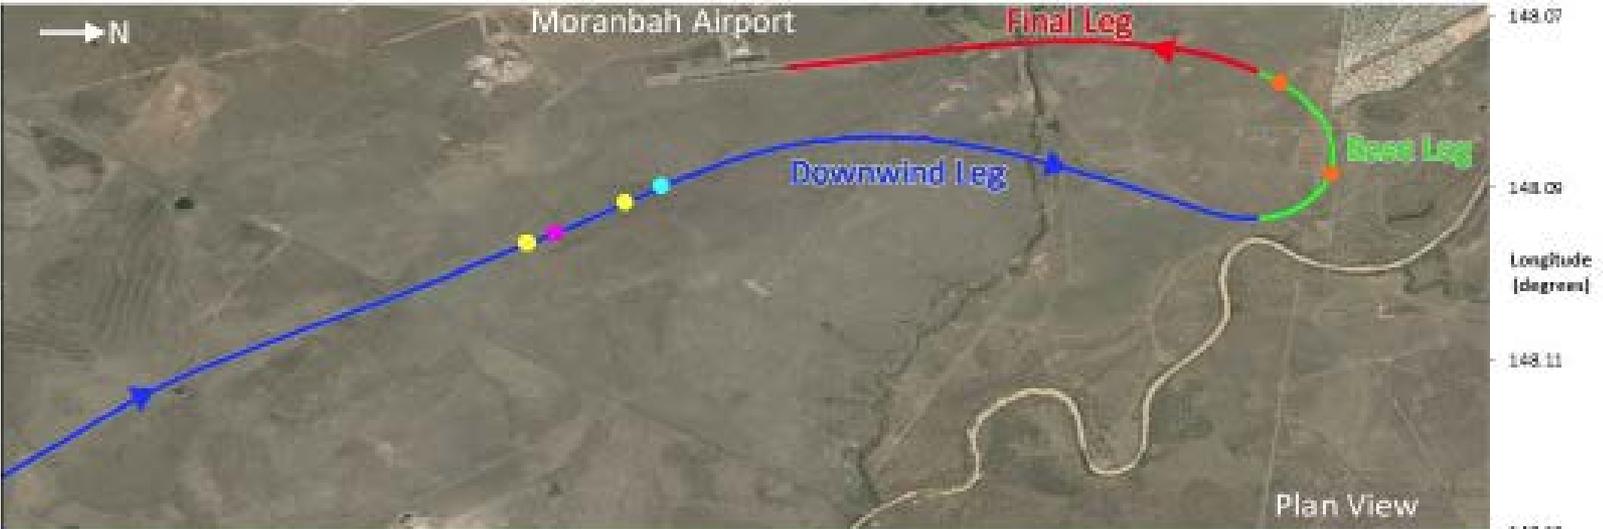
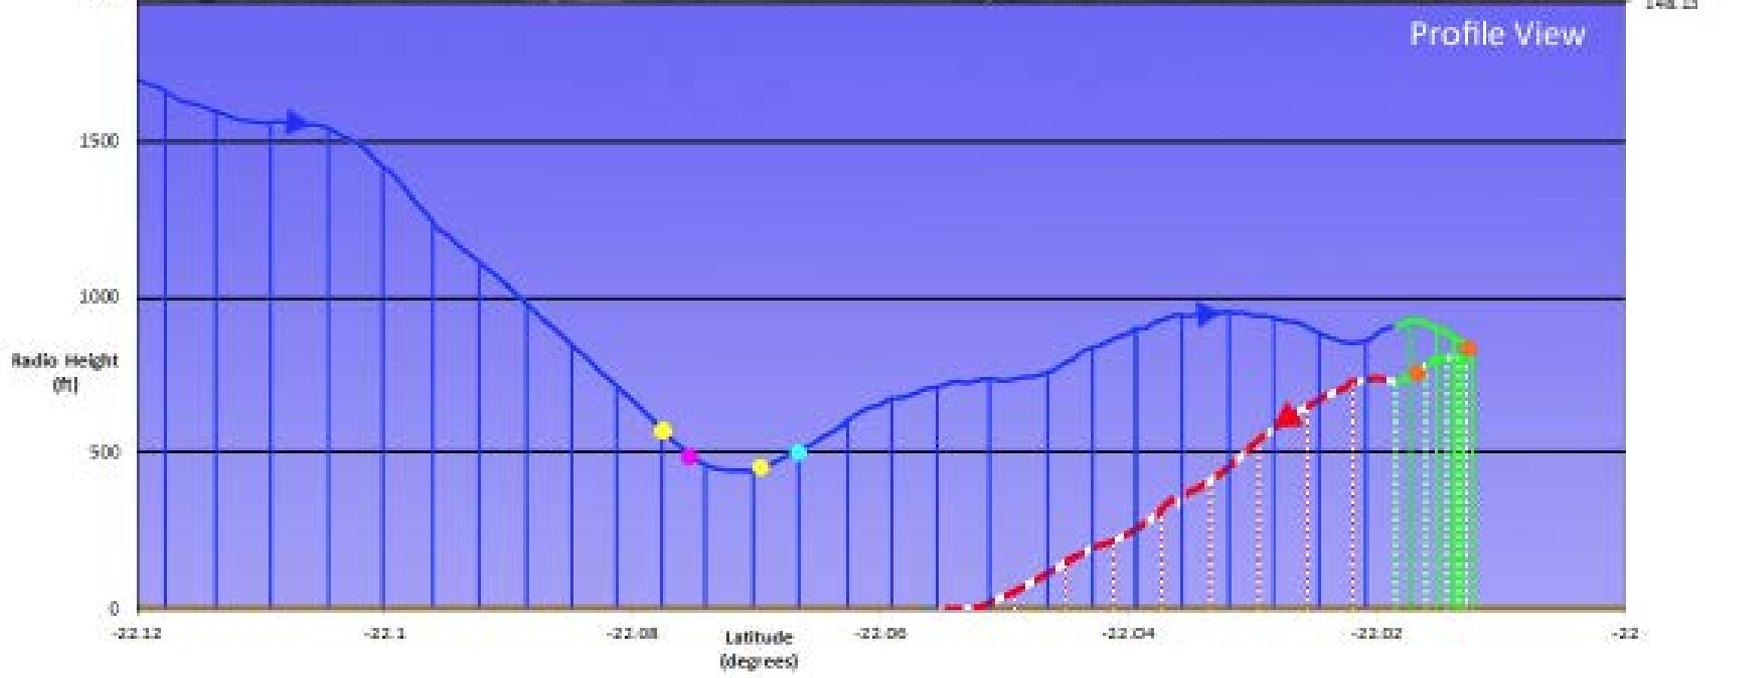
- During the descent, the aircraft's vertical speed increased and the first TAWS alert 'Too low Terrain' activated passing 560 ft AGL
- Another 3 TAWS alerts activated within 12 seconds of the aircraft being levelled at 440 ft AGL
- The crew reported the base of the cloud was at about 500 ft AGL
- the captain had commenced levelling the aircraft just prior to the TAWS alerts.

- The crew elected to continue, and climbed the aircraft to 1,500 ft, which was about 870 ft AGL while configuring for landing
- Another TAWS alert activated 'Don't sink' during the turn onto base. This was considered spurious as the aircraft was not descending at that time
- The crew reported being stabilised by 500 ft AGL and a normal landing was conducted

- During the start of the cloud avoidance descent, the FO was concentrating on completing necessary tasks and was not expecting a descent at that time
- The captain decided to descend and conducted this action while announcing it to the FO. This was without first discussing it or nominating any descent limits
- The FO later reported:
 - understood what the captain was doing
 - did not need to call the high descent rate once identified as this would exacerbate the captain's workload

- Both crew felt the cloud base would be able 300-400 ft below circuit height
- Lack of discussion about the descent (as opposed to tracking around the cloud or reverting to an NDB approach) negated any opportunity for the crew to recognise the descent rate was higher than anticipated
- During the descent, the captain was focused on avoiding the cloud, and FO was completing tasks
- Subsequently, the descent rate went unnoticed.
