Australian Government
Australian Transport Safety Bureau

Some observations from recent ATSB investigations

PACDEFF 2023

Mike Walker

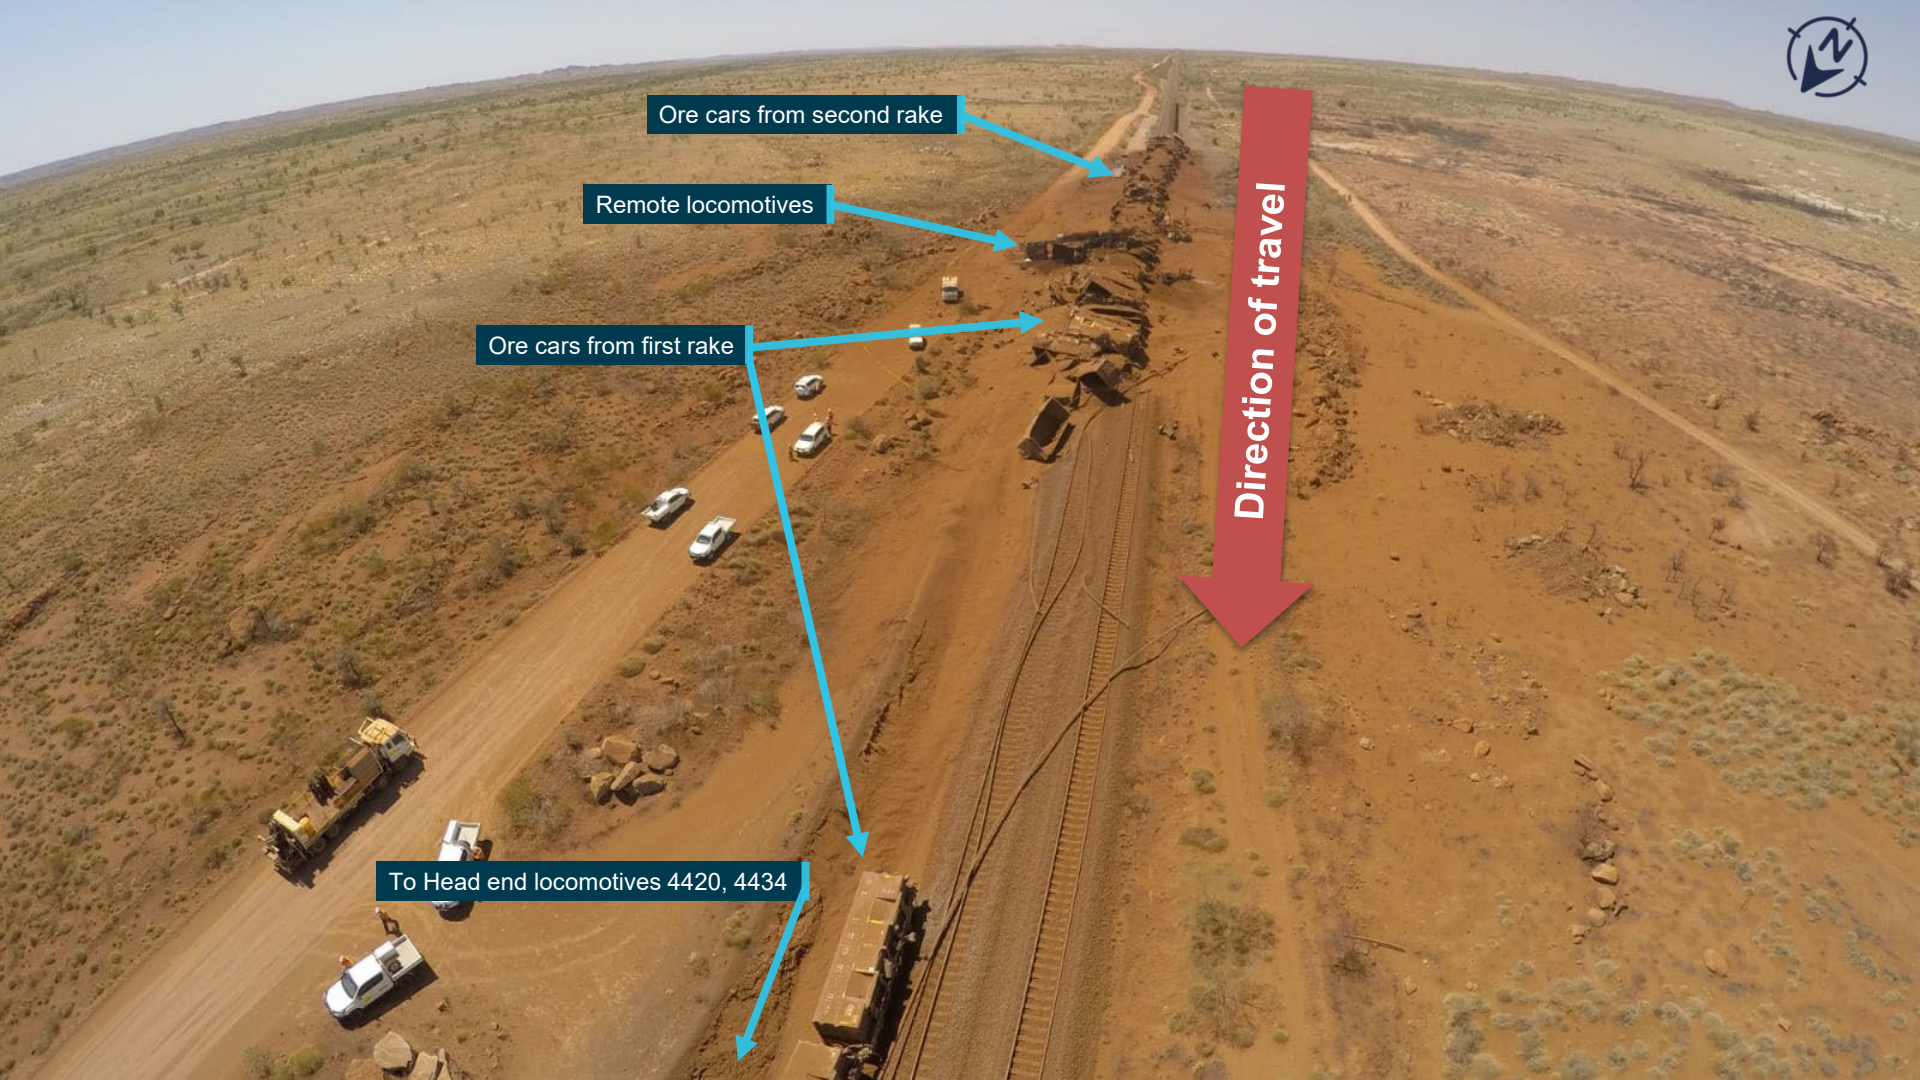
- Loaded ore train en route to Port Hedland
- Electronically controlled pneumatic braking (ECPB) overlay system
- Trainline communication lost, triggered automated ECPB emergency brake command, stopped train on a down grade
- Driver commenced applying handbrakes
- ECP brake application released after 60 minutes (as designed)
- Train rolled away with no driver, travelled 91 km at speeds up to 162 km/h
- Intentionally derailed (speed 144 km/h)
- 2 locos, 245 wagons destroyed

Ore cars from second rake

Remote locomotives

Ore cars from first rake

To Head end locomotives 4420, 4434

Direction of travel

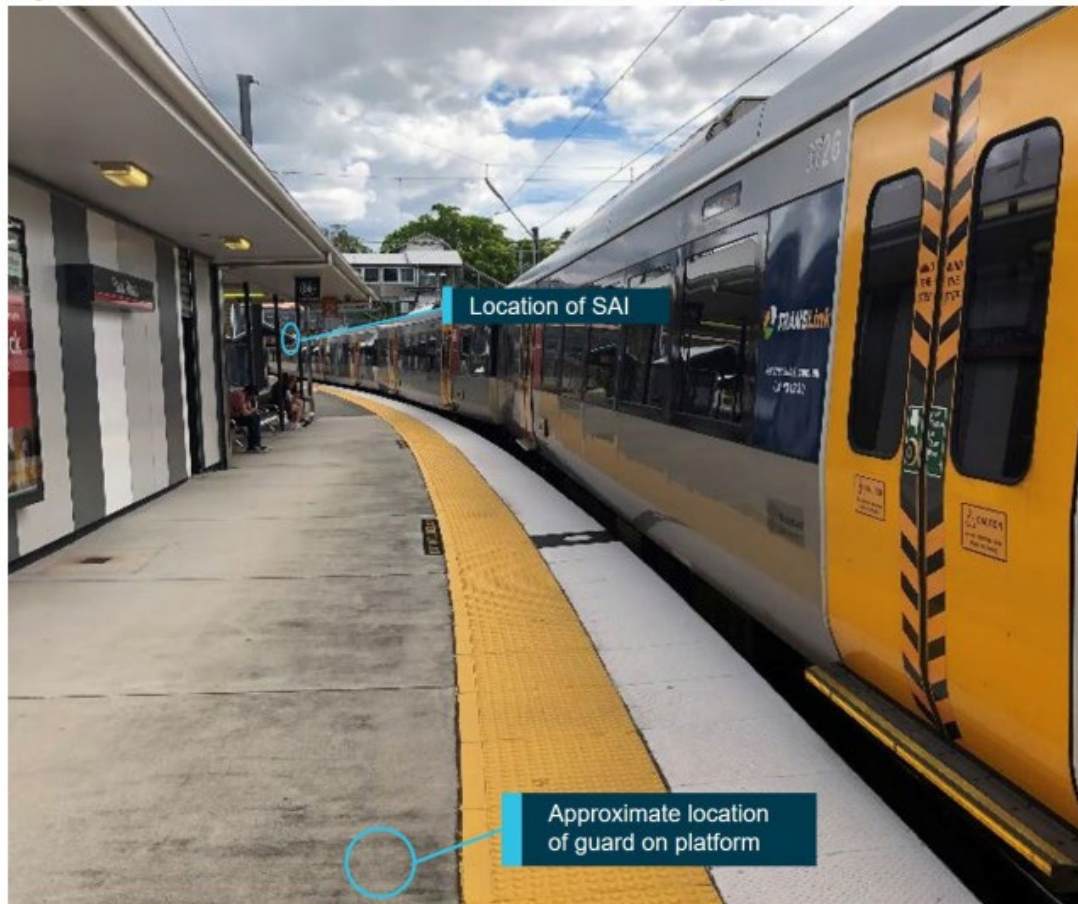
Figure 8: Location of the SAI relative to the location of the guard at Park Road platform 2

- At CBD stations, station staff provided guards with allright signal for all trains (informal practice to check departure signal)
- Dec 2017: NGR commenced operations (other train types still used)
 - NGR operating model placed guard at rear of train
 - guards could no longer see departure signals at some stations, new signal aspect indicators (SAIs) required
 - passengers needing assistance still in middle of train, required more involvement from station staff
- Jan 2019: station staff at suburban stations required to provide allright signal for all NGR services (but not check departure signal)
- 5 SPADs involving NGR trains at suburban platforms from March 2019 to March 2020 (and 6th in April 2021)

- Multiple processes did not effectively consider the risk of station staff at suburban platforms providing the allright signal for all NGR trains when the platform departure signal displayed a stop indication.
- Process for the installation of SAIs did not provide sufficient detail to ensure consistent and conspicuous placement of SAIs at station platforms.

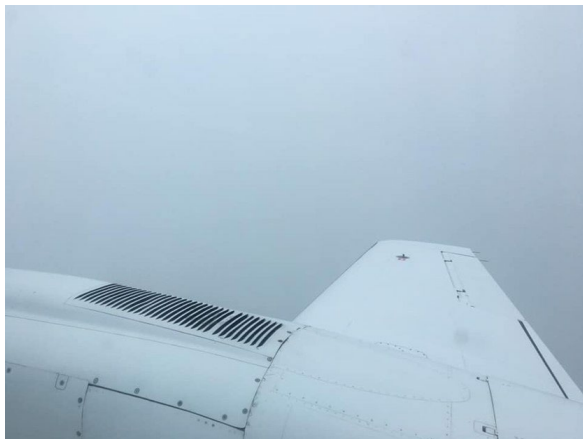
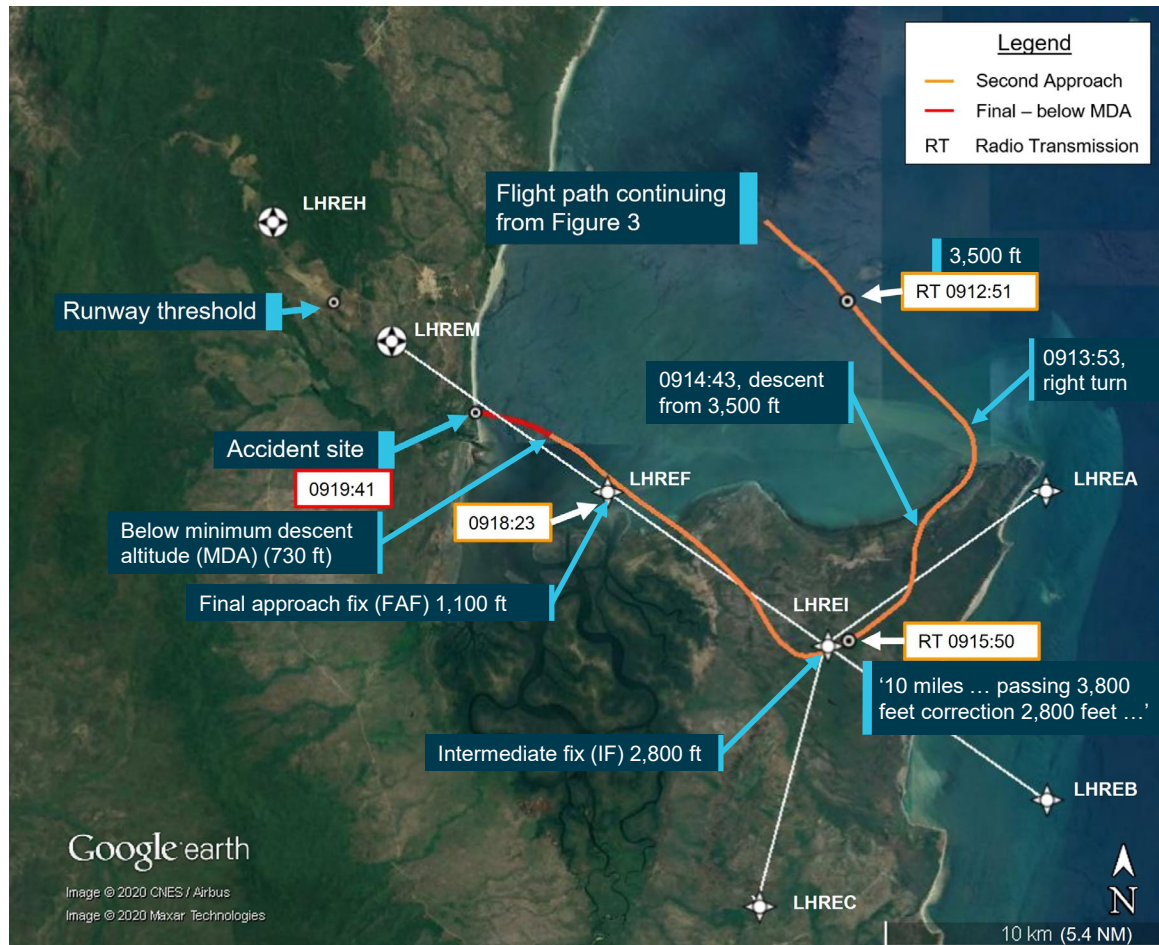
Approach 2

- Second approach and collision

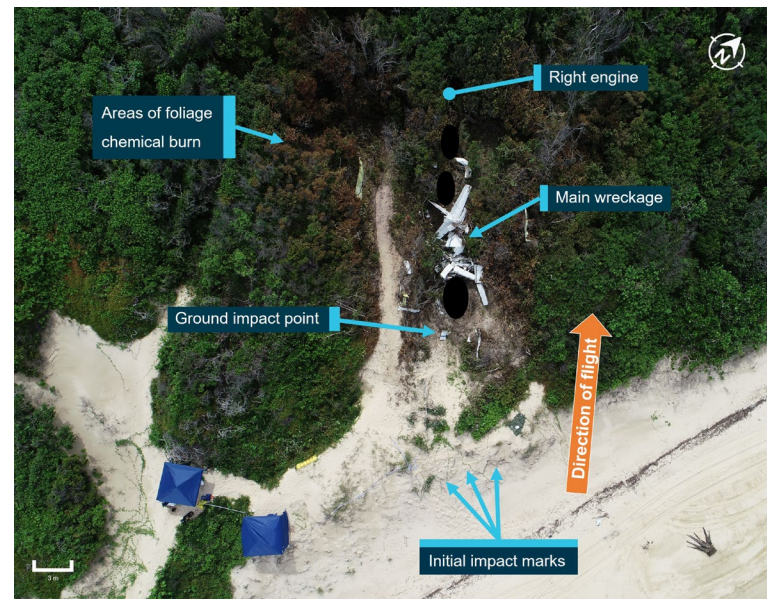
Accident site

- Impacted sand dune
 - 3.5 NM (6.4 km) short of runway
 - 2.1 NM (3.9 km) before MAPt
- Key points:
 - upright and wings-level
 - 5 degrees nose down
 - high speed (not survivable)
 - significant amount of fuel on board
 - engines – substantial power
 - landing gear extended

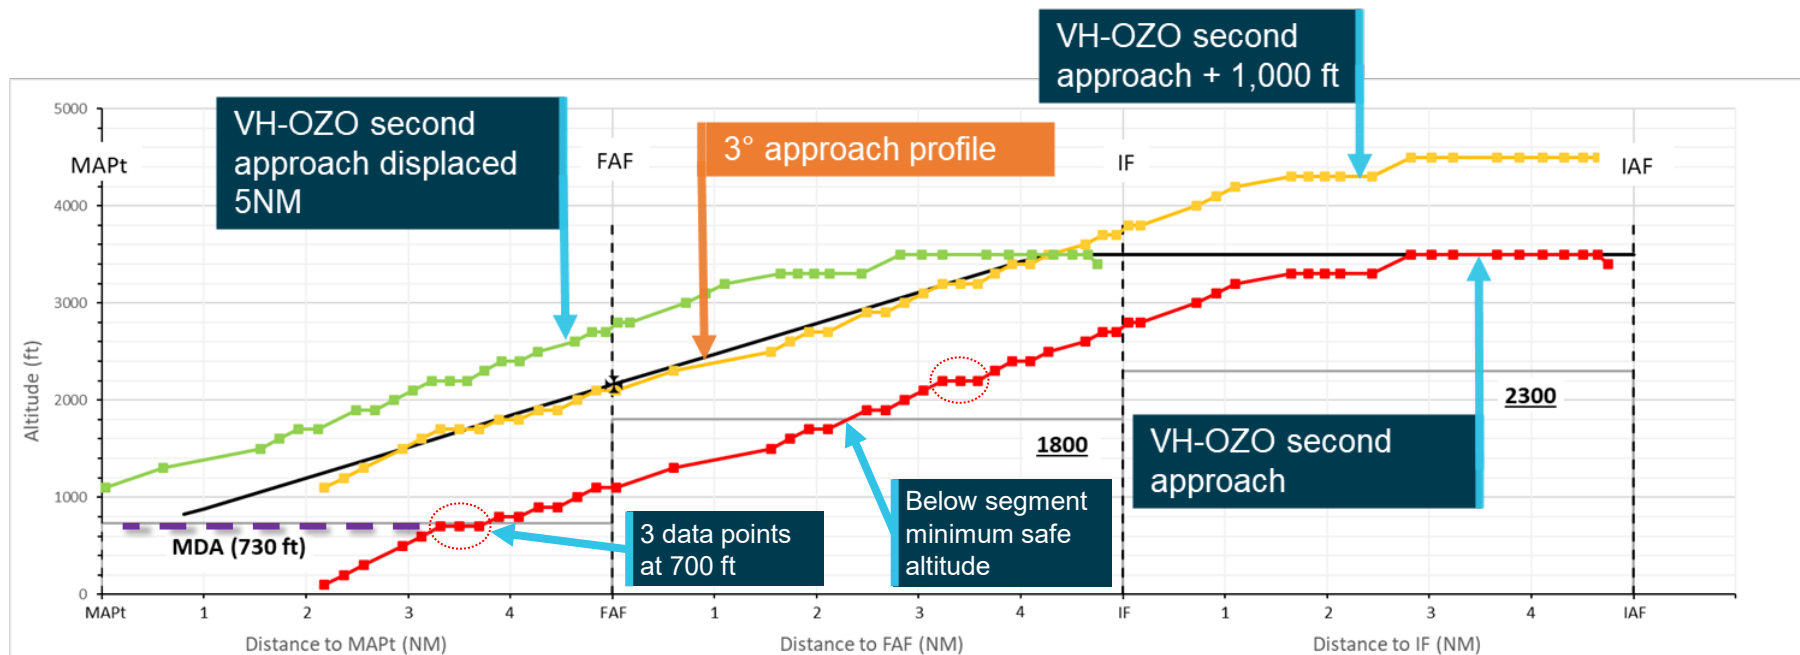
Recorded data for second approach

- 3 main scenarios:
 - 1 – misunderstood position along the approach
 - 2 – believed aircraft was 1,000 ft higher
 - 3 – intentionally descended early to try to gain visual reference
- Most likely scenario was believing 1,000 ft higher (altimeter misreading) but insufficient evidence for a definitive conclusion
- Regardless of scenario, altitude was not being effectively monitored for extended period

Scenario 1 – misunderstood position along approach

Scenario 2 – believed 1,000 ft higher

Scenario 3 – intentionally descended early to try to gain visual reference

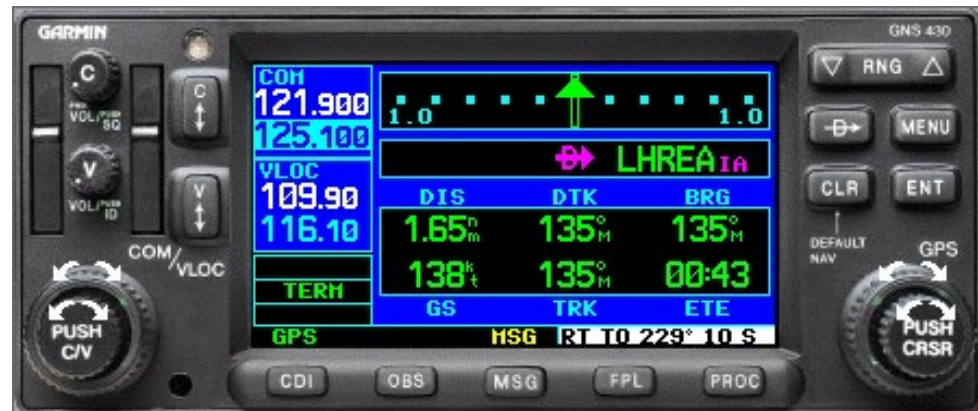
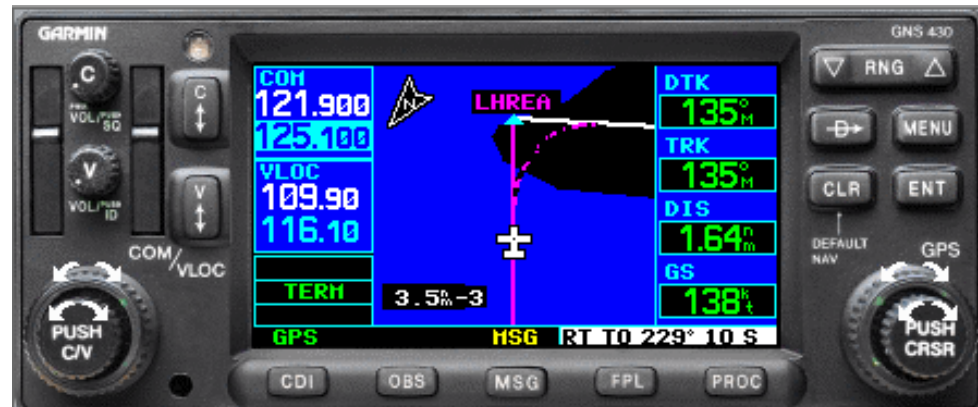
Simulations of NAV default page (top) and map page (bottom) prior to reaching LHREA

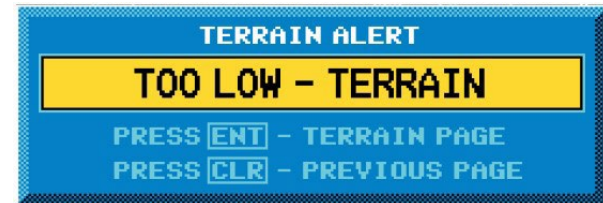
Premature descent alert
