Australian Government
Australian Transport Safety Bureau

Some observations from recent ATSB investigations

PACDEFF 2023

Mike Walker

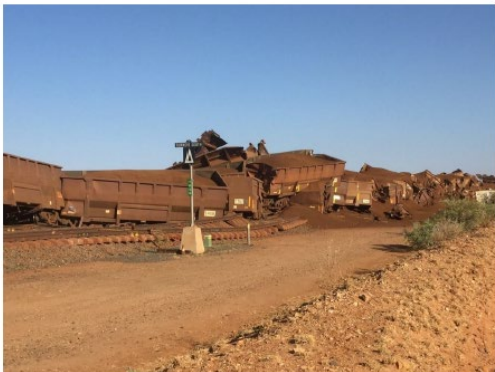
Runaway and derailment of loaded ore train M02712

Near the 211 km mark south of Port Hedland, Western Australia, on 5 November 2018

- Loaded ore train en route to Port Hedland
- Electronically controlled pneumatic braking (ECPB) overlay system
- Trainline communication lost, triggered automated ECPB emergency brake command, stopped train on a down grade
- Driver commenced applying handbrakes
- ECP brake application released after 60 minutes (as designed)
- Train rolled away with no driver, travelled 91 km at speeds up to 162 km/h
- Intentionally derailed (speed 144 km/h)
- 2 locos, 245 wagons destroyed

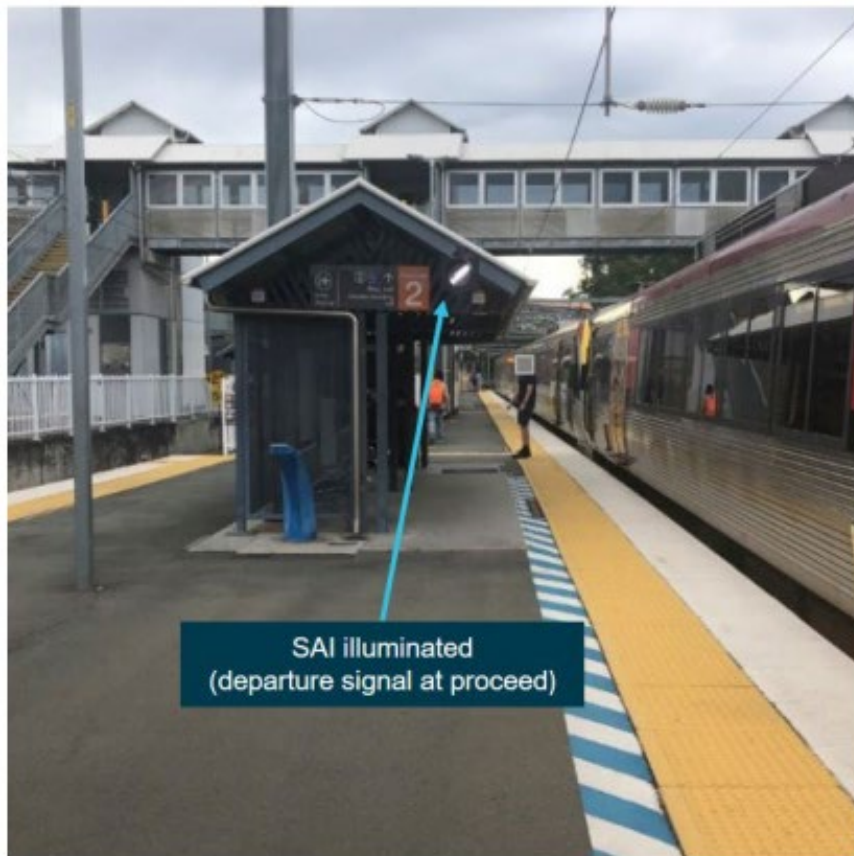
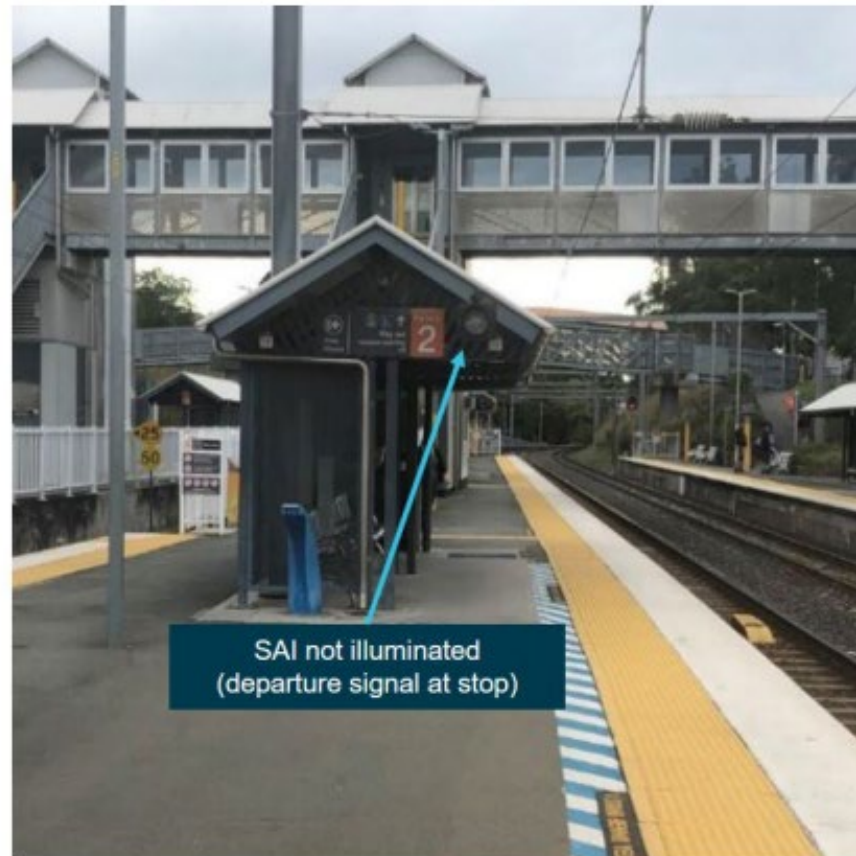
Figure 8: Location of the SAI relative to the location of the guard at Park Road platform 2

- At CBD stations, station staff provided guards with allright signal for all trains (informal practice to check departure signal)
- Dec 2017: NGR commenced operations (other train types still used)
 - NGR operating model placed guard at rear of train
 - guards could no longer see departure signals at some stations, new signal aspect indicators (SAIs) required
 - passengers needing assistance still in middle of train, required more involvement from station staff
- Jan 2019: station staff at suburban stations required to provide allright signal for all NGR services (but not check departure signal)
- 5 SPADs involving NGR trains at suburban platforms from March 2019 to March 2020 (and 6th in April 2021)

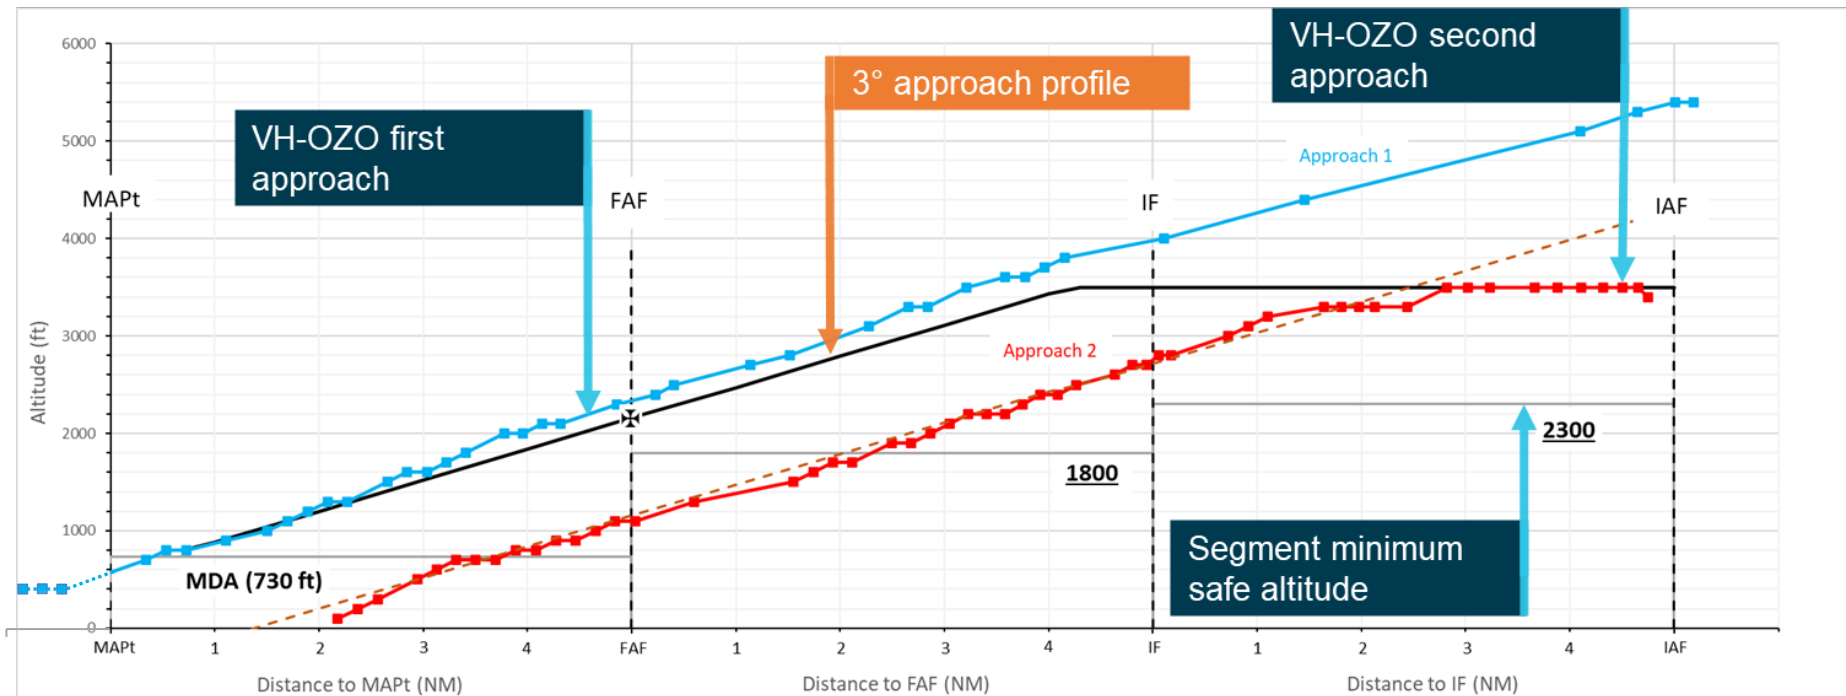
Recorded altitude

- 3 main scenarios:
 - 1 – misunderstood position along the approach
 - 2 – believed aircraft was 1,000 ft higher
 - 3 – intentionally descended early to try to gain visual reference
- Most likely scenario was believing 1,000 ft higher (altimeter misreading) but insufficient evidence for a definitive conclusion
- Regardless of scenario, altitude was not being effectively monitored for extended period

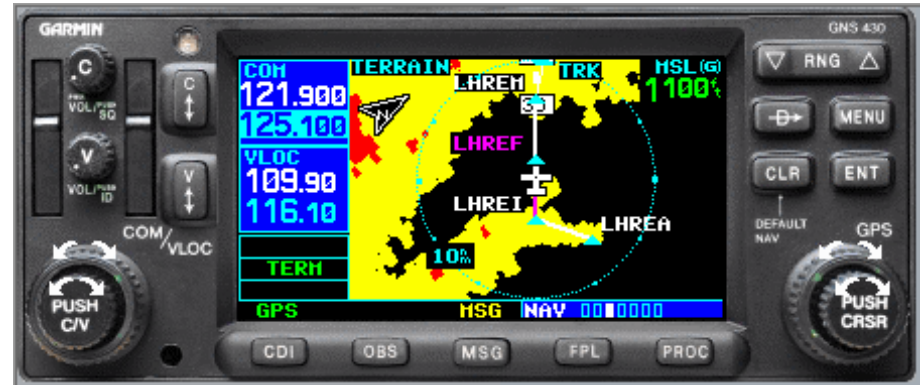
Simulation of NAV terrain page

- Not equivalent to a TAWS
- Supplemental awareness only
- Advisory info on terrain page
- Visual ‘pop-up’ alerts
 - premature descent
 - forward-looking terrain avoidance
- No aural alerts or altitude callouts
- Alerting function can be inhibited
- Alerting function is often inhibited
