PACDEFF & AAvPA 2025

Montague Street Bridge
South Melbourne

Safety & Organisational Accountability

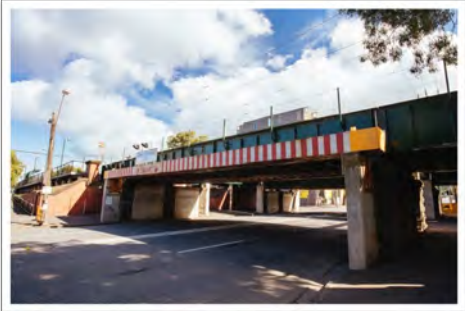
- Montague Street Light Rail Bridge, South Melbourne
- Inner urban, close to a major off-ramp of the M1 motorway
- Heavy commuter and industrial traffic
- Clearance of just three metres (9.84 feet) between the road surface and the lowest part of the bridge

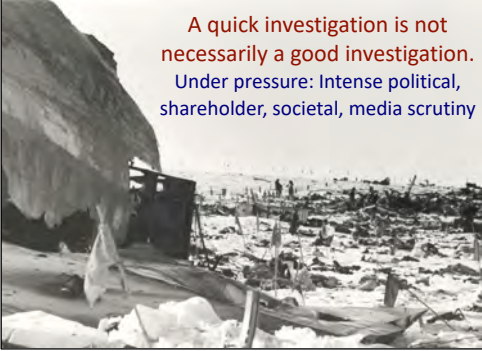
This view of the crash site, looking downhill through the wreckage of Air New Zealand Flight TE901 towards the Lewis Bay sea ice, shows a maze of body location flags. Photograph taken by Colin Monteath of the Antarctic Division in December 1979. (Image: Archives New Zealand)

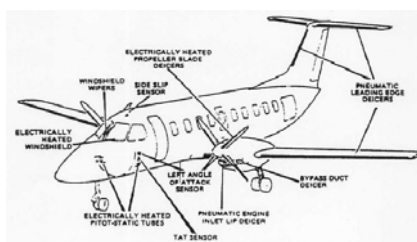
- Overnight maintenance was scheduled for the night before the accident, including removal and replacement of de-icing boots on the leading edge of the horizontal stabilizer.

- The work was conducted across two shifts. An inspector on the first shift, deciding to assist, removed the 47 screws from the upper surface of the right side of the horizontal stabiliser, then crawled over to the left side to do the same.

- After the shift change, the next supervisor decided that his crew would complete work on the right leading-edge assembly only, leaving work on the left side for a later date.

- No additional work was done on the left side of the stabiliser, with the second shift maintenance crew apparently unaware that the left side upper surface screws had been removed.

- During the accident investigation it was found that the 47 left side screws were missing from the aircraft wreckage, and no trace of the missing screws was ever found.

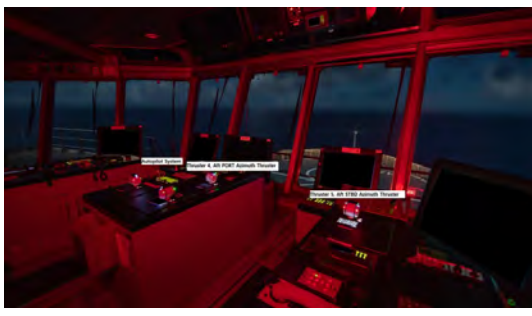
- “The direct cause of the grounding has been determined as **a series of human errors** which meant the ship’s autopilot was not disengaged when it should have been,” Rear Admiral Golding said.
- “The crew did not realise Manawanui remained in autopilot and ... mistakenly believed its failure to respond to direction changes was the result of a thruster control failure.
- “Having mistakenly assessed a thruster control failure, standard procedures **should have prompted ship’s crew to check** that the ship was under manual control rather than in autopilot. This check did not occur.”

21. The direct cause of the grounding has been determined as a series of human errors in that the Ship was put on a heading towards land and the autopilot mode was not disengaged to enable the Ship to turn in an easterly direction. Remaining in autopilot resulted in the Ship maintaining a course of 340° toward land, until grounding and eventually stranding.

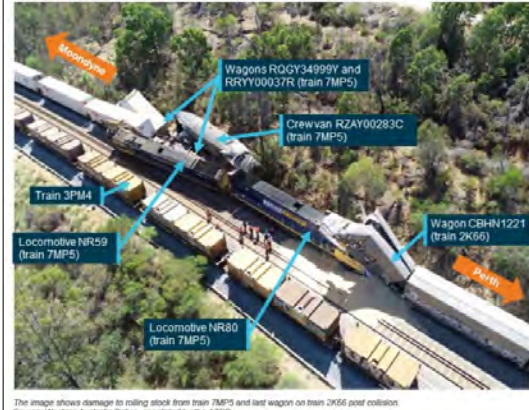
Figure 5: Accident site, lead locomotive of 7MP5 and last wagon of 2K66 post collision

The image shows damage to rolling stock from train 7MP5 and last wagon on train 2K66 post collision. Source: Western Australia Police, annotated by the ATSB

The collision occurred at about 02:00 am on 24 December 2019.

7MP5 was a driver only operation travelling towards Perth in the same direction as 2K66 but about 28 km behind.

2K66 was stopped to allow a freight train travelling in the opposite direction to pass.

At about 01:56 7MP5 passed a signal set at **Caution** and three minutes later passed another signal set at **Stop** (Signal Passed at Danger ~ SPAD).

At that point 7MP5 was travelling at a speed of 72 km/h and was about 800 m from the rear of 2K66.

Emergency braking was applied about 175 m from the rear of 2K66, reducing the impact speed to 41 km/h, but too late to avoid a collision.
